**HURRICANE KATRINA:
WHY DID THE LEVEES FAIL?**

**COMMITTEE ON
HOMELAND SECURITY AND
GOVERNMENTAL AFFAIRS
UNITED STATES SENATE**

NOVEMBER 2, 2005

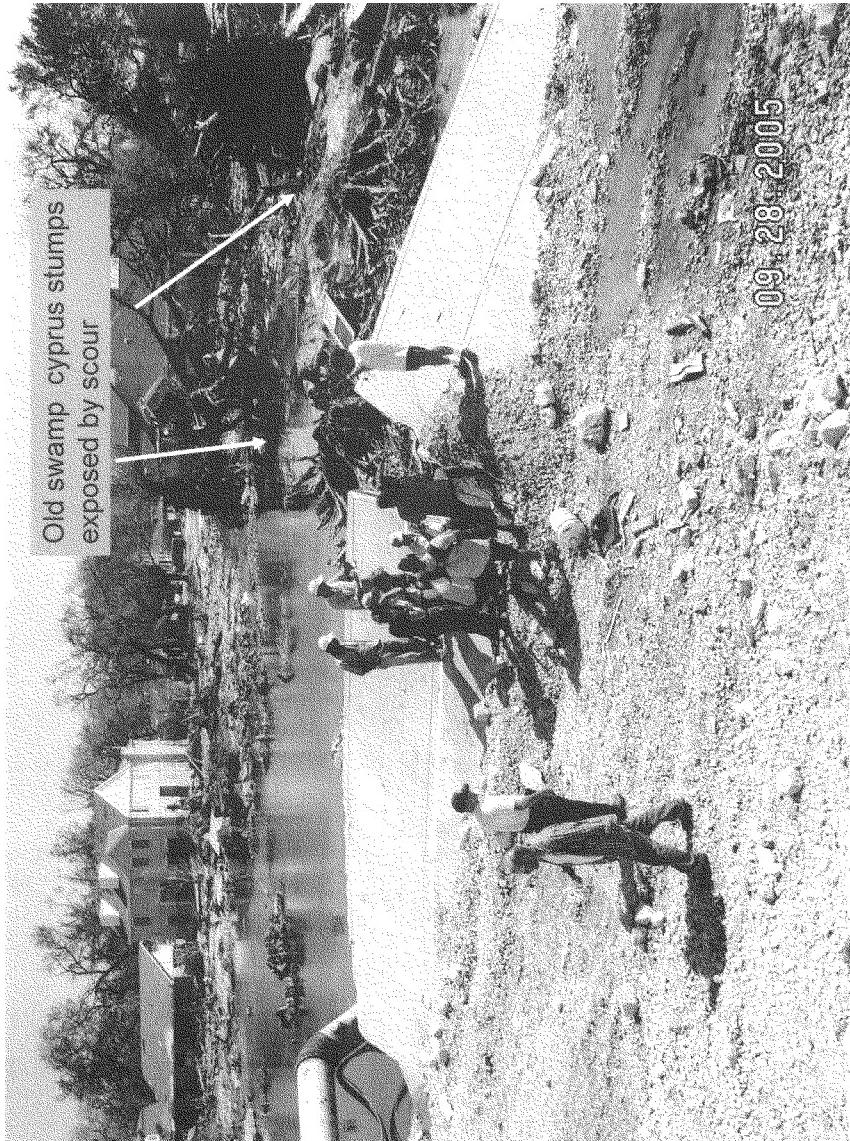
17th Street Canal 'Heaved' yard
behind levee wall that moved
35 feet laterally

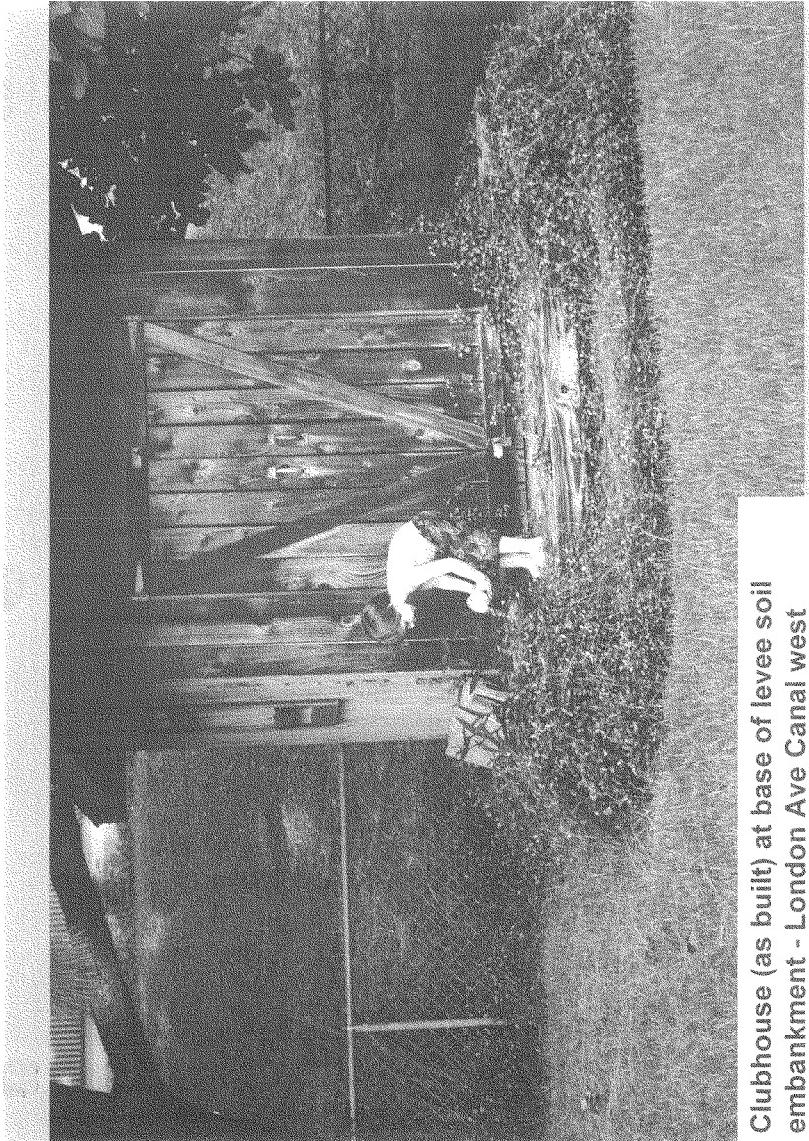
Clubhouse (as built) at base of levee soil embankment - London Ave Canal West breach. Note pine tree location on left.

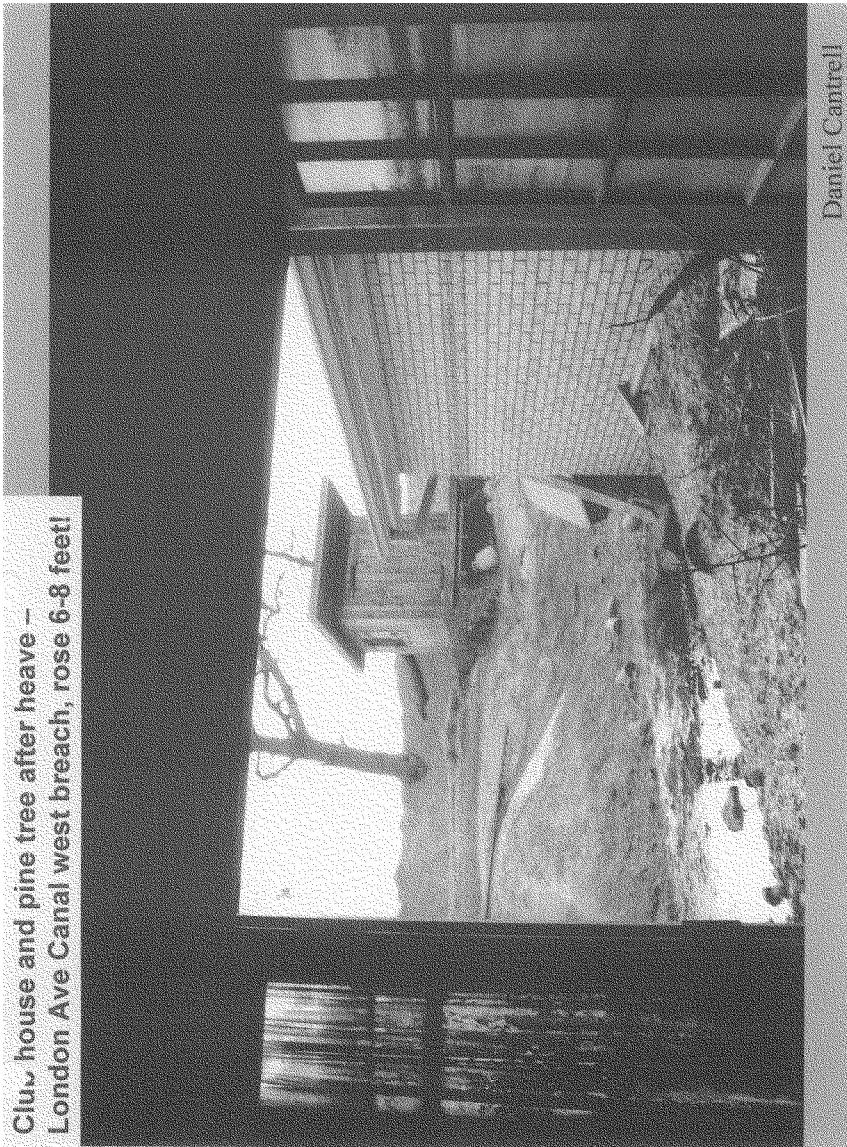
Clue house and pine tree after heave –
London Ave Canal west breach, rose 6-8 feet!

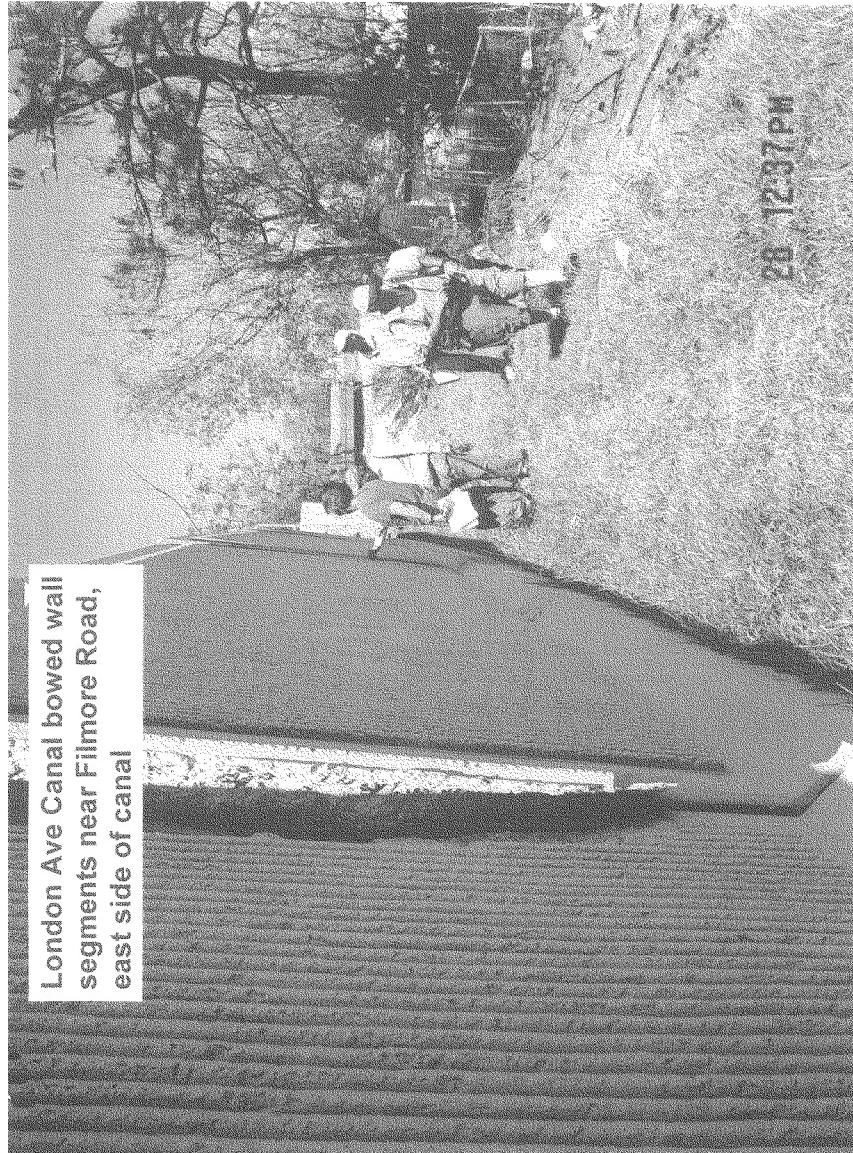
London Ave Canal bowed wall
Segments near Filmore Road,
east side of canal

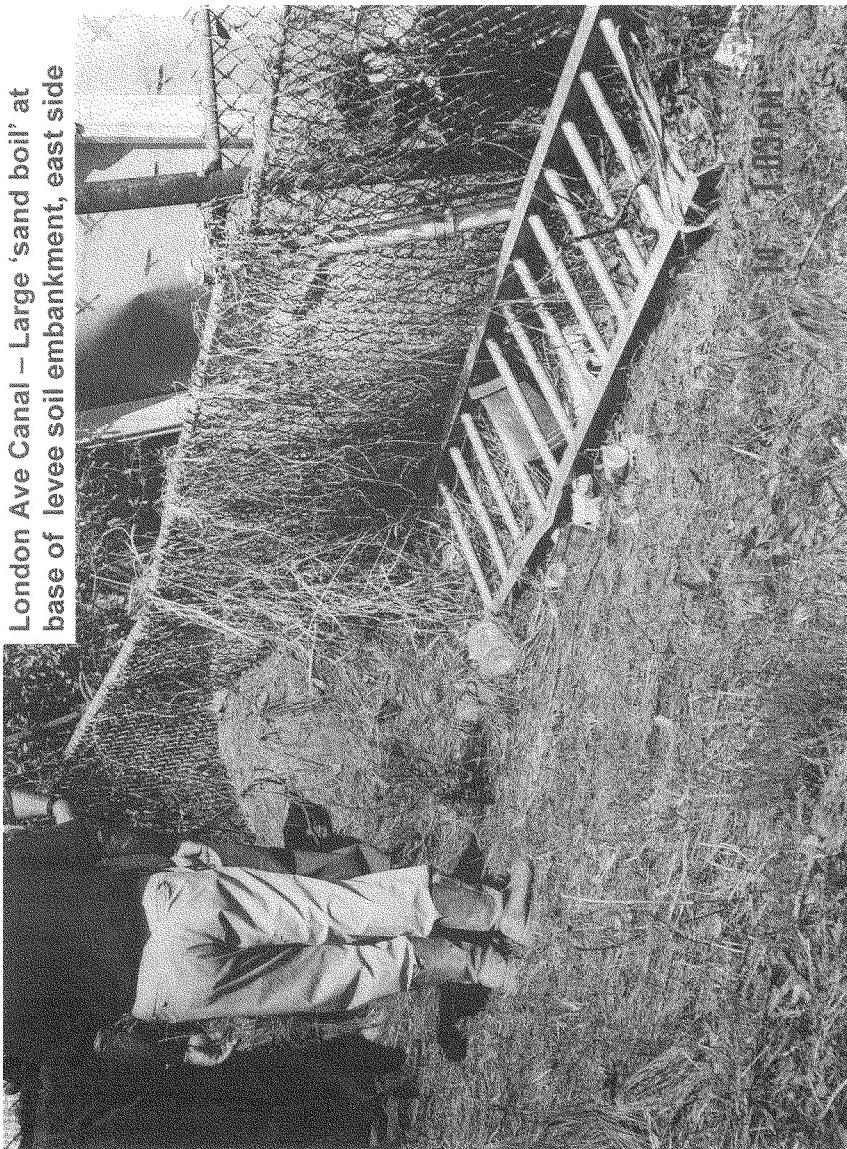
London Ave Canal – Large 'sand boil' at
base of levee soil embankment, east side

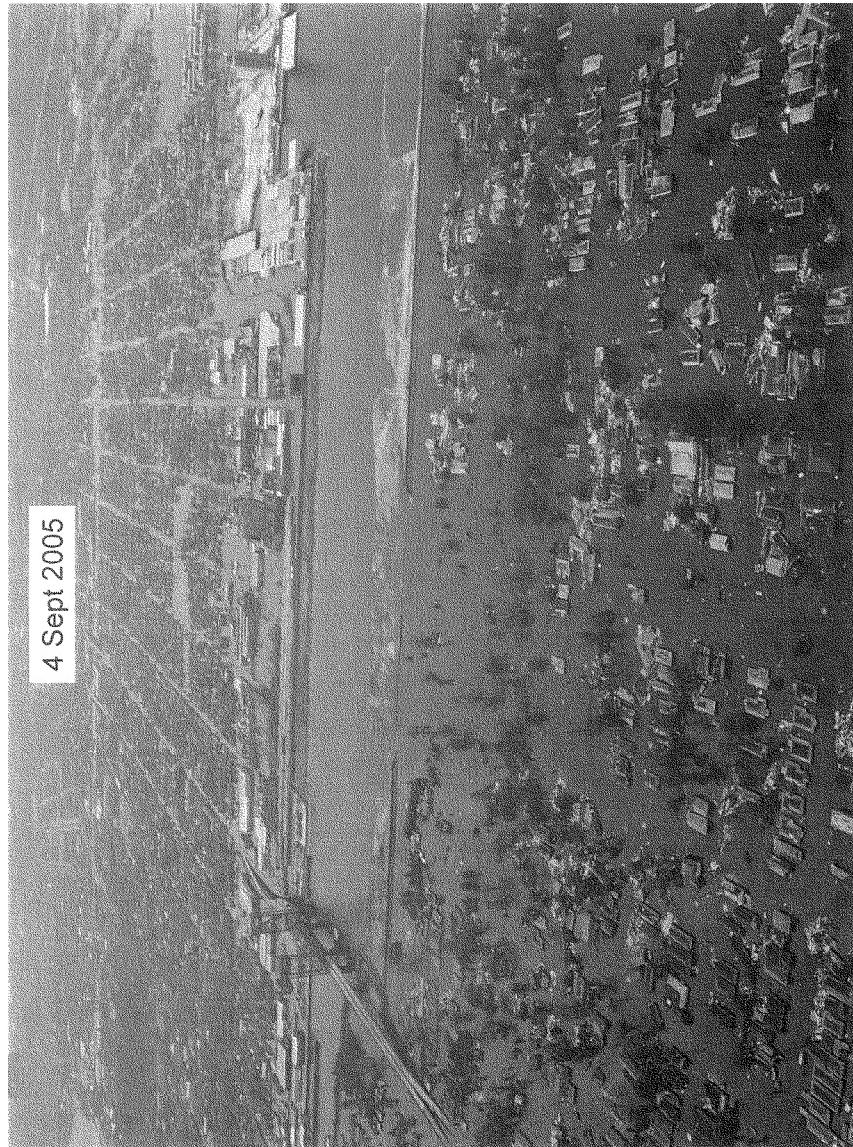
Levee Failure on East Side of Industrial Canal

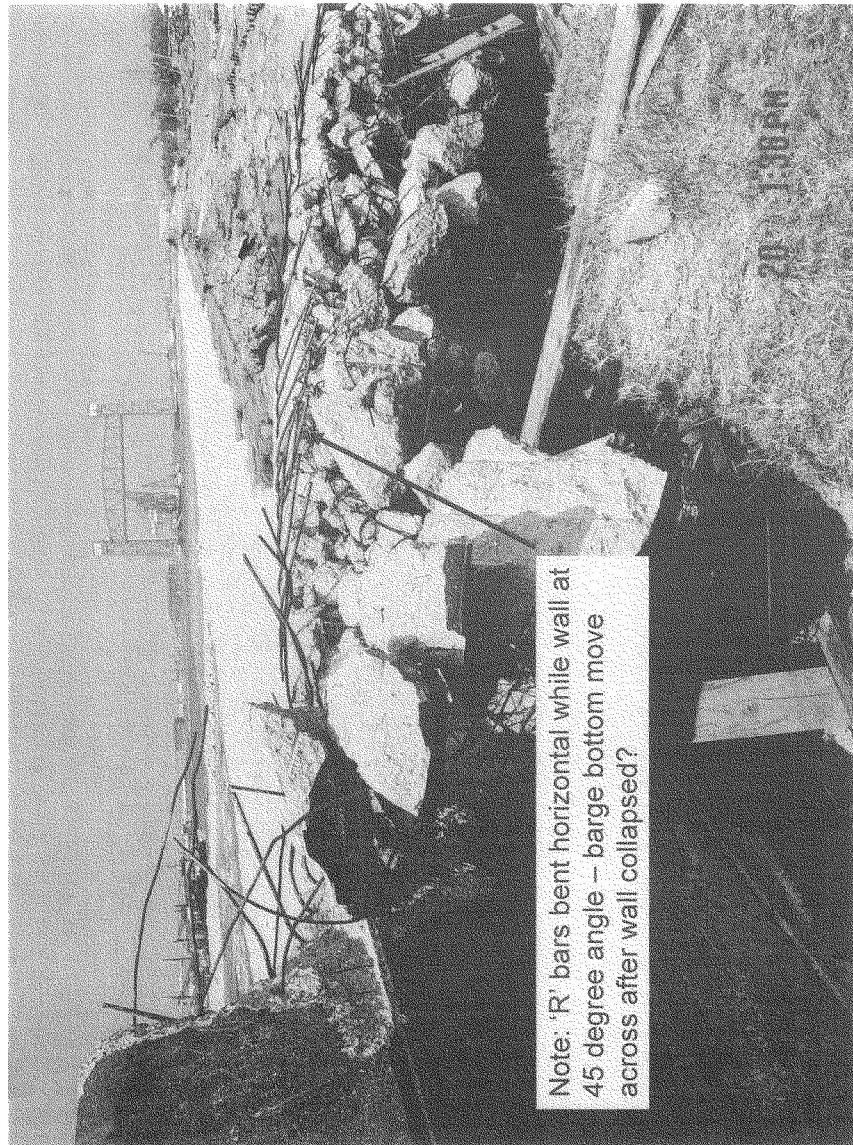
Note: 'R' bars bent horizontal while wall at
45 degree angle – barge bottom move
across after wall collapsed?

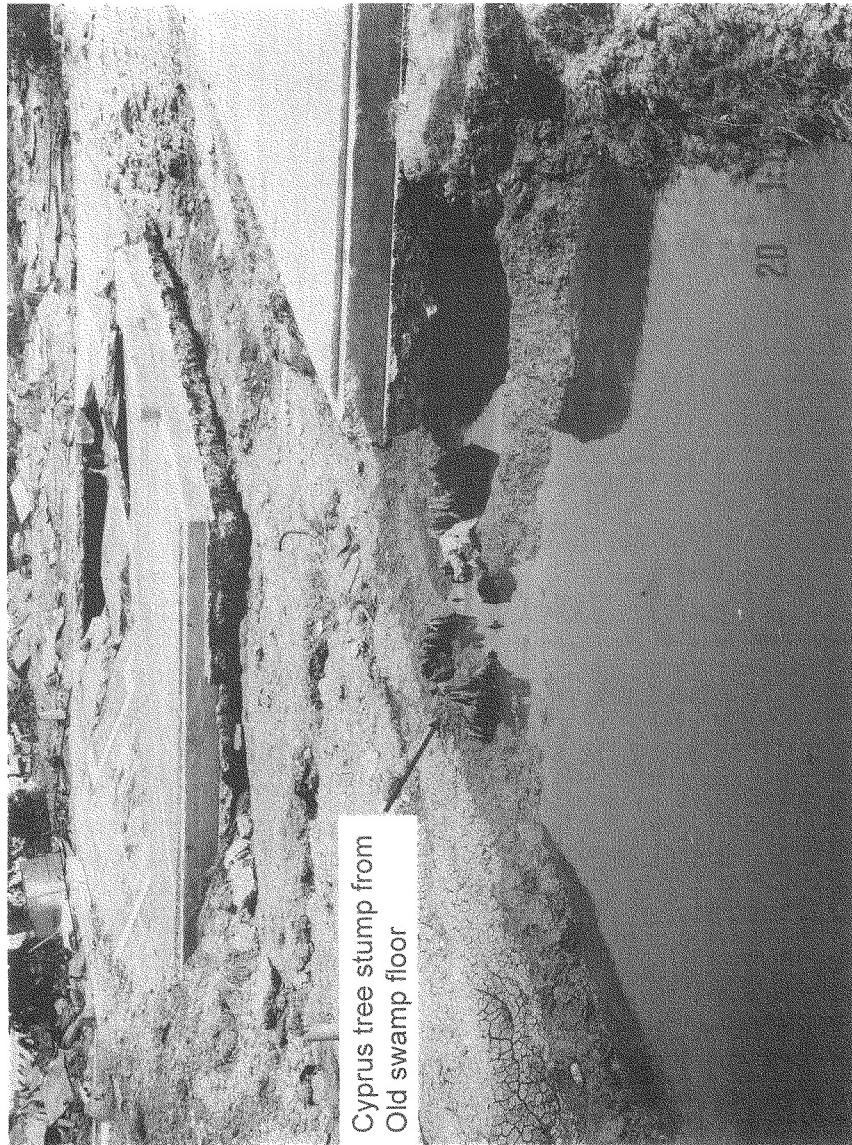
Cypris tree stump from
Old swamp floor

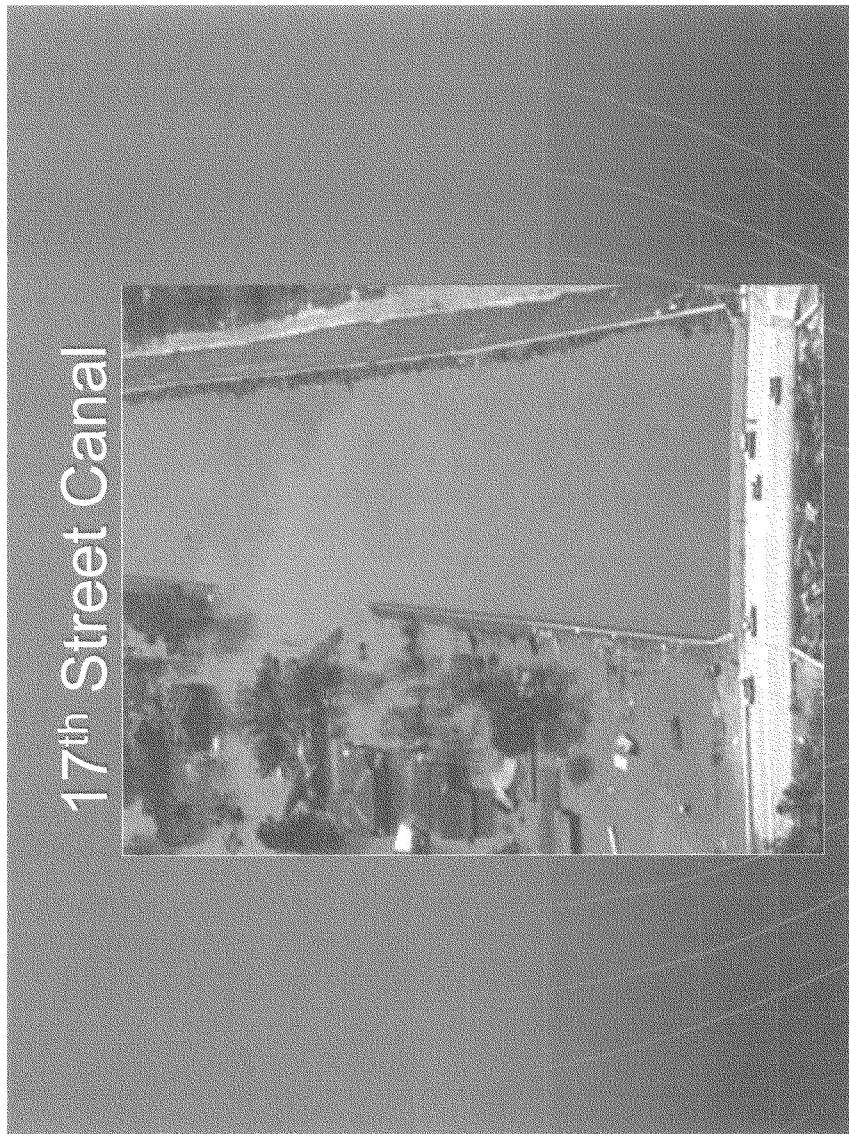
At the 17th Street Canal breach, we observed intact soil blocks that had experienced large translation and heave. This movement would be consistent with a failure either of

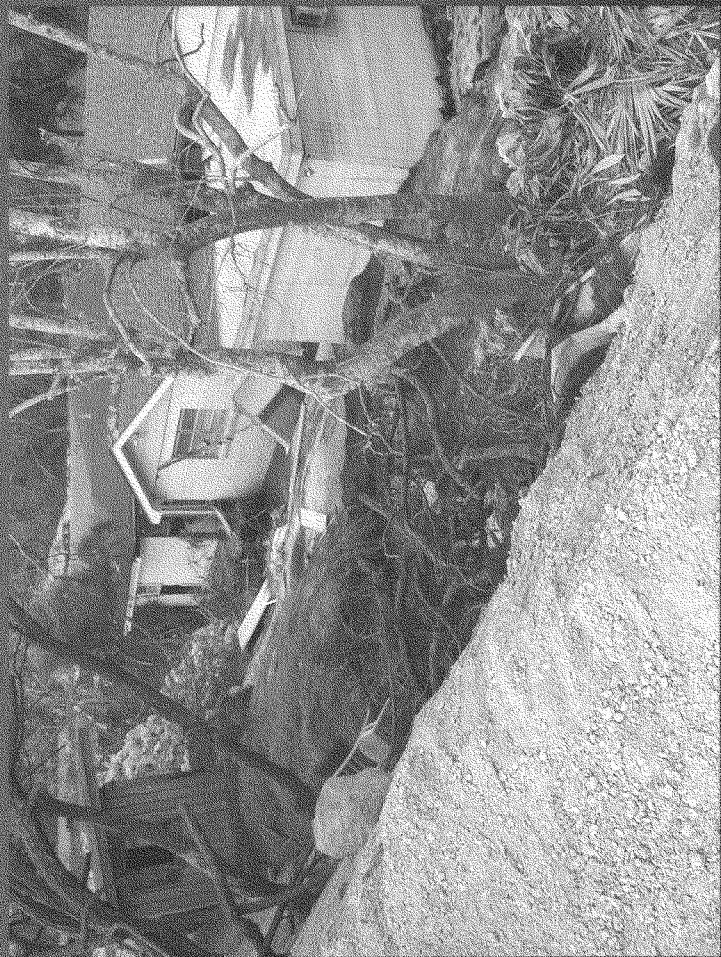
London Avenue Canal, North Breach

At the north breach on the London Avenue Canal, we observed a large displaced soil mass, which had been heaved nearly vertically over six feet, apparently indicating the toe of a rotational-type soil failure. Again, there was no evidence of overtopping at this site. Field inspection also showed a large amount of sandy soil deposited in the neighborhood landward of the breach, which is believed to be material from the foundation beneath the embankment together with material scoured from the canal bottom. This is consistent with the soil profiles provided to us which showed sand in the subsurface near this location. Under high water pressure, the flow through this type of material can be significant, which is known to cause internal stability problems.

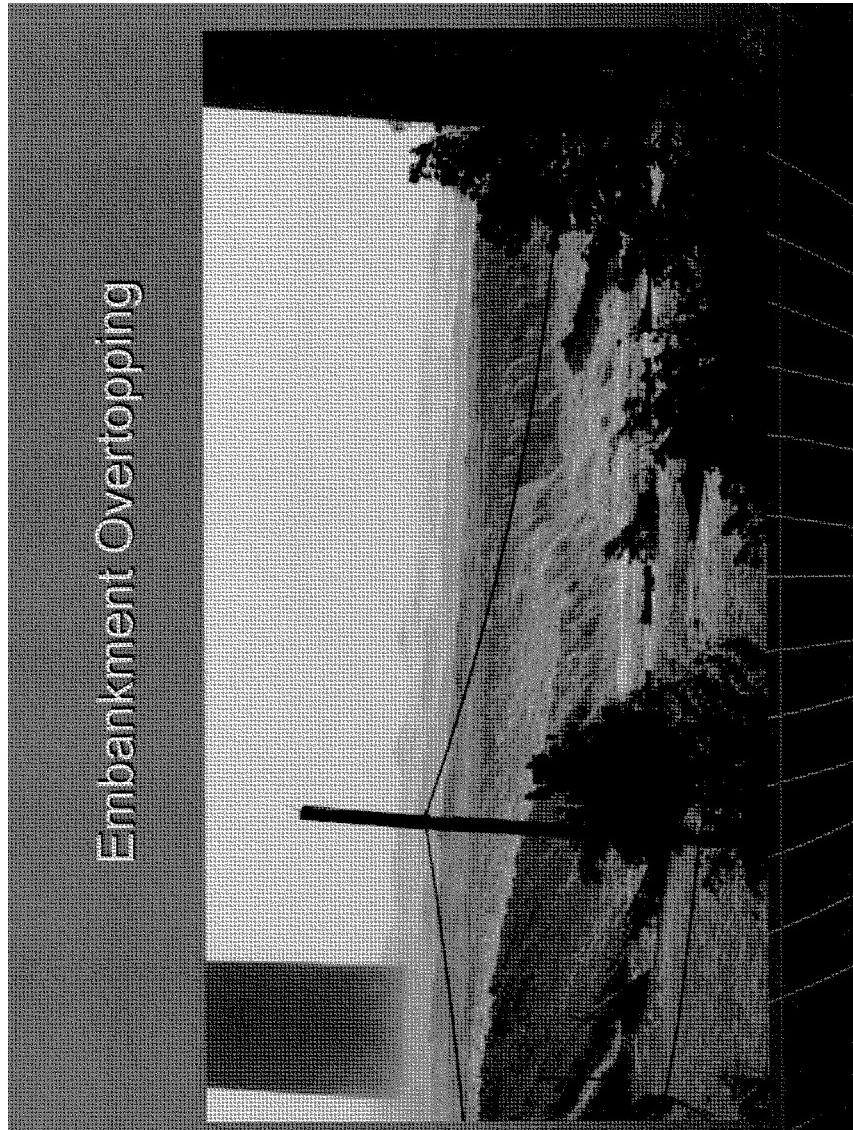
Embankment Overtopping

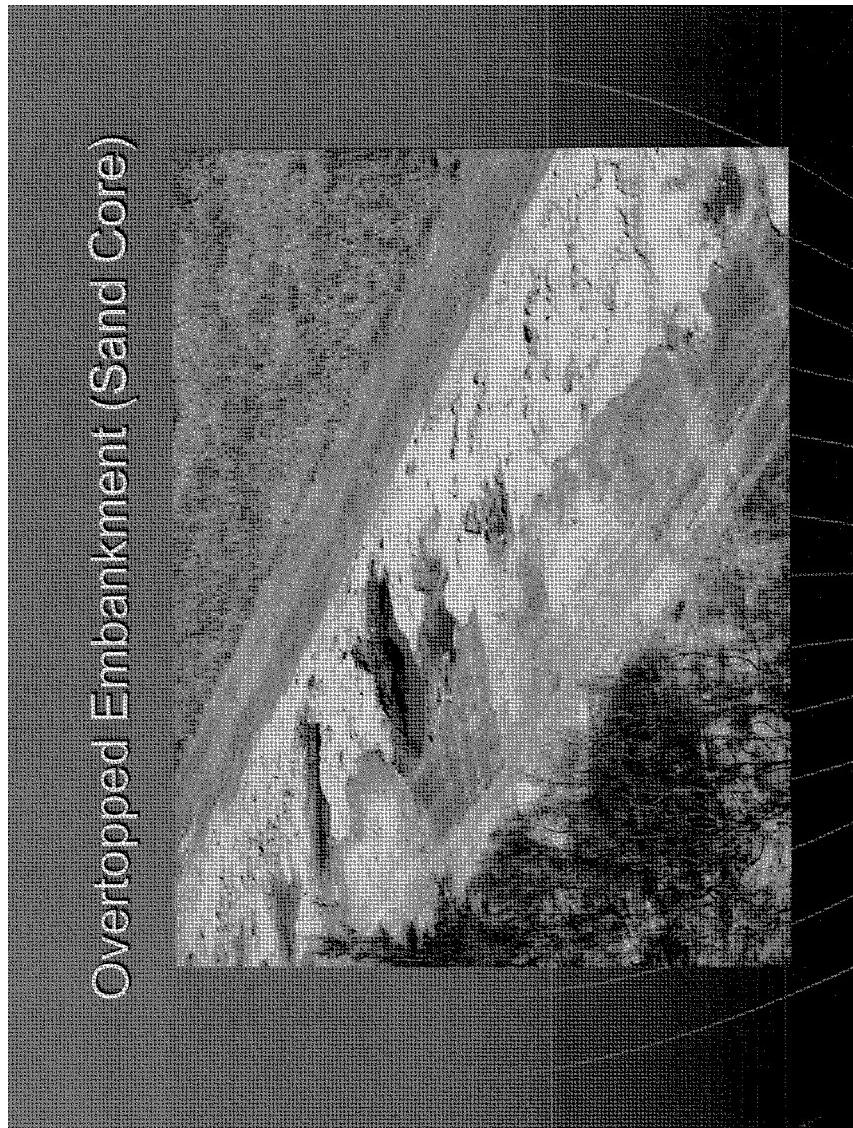
Overtopped Embankment (Sand Core)

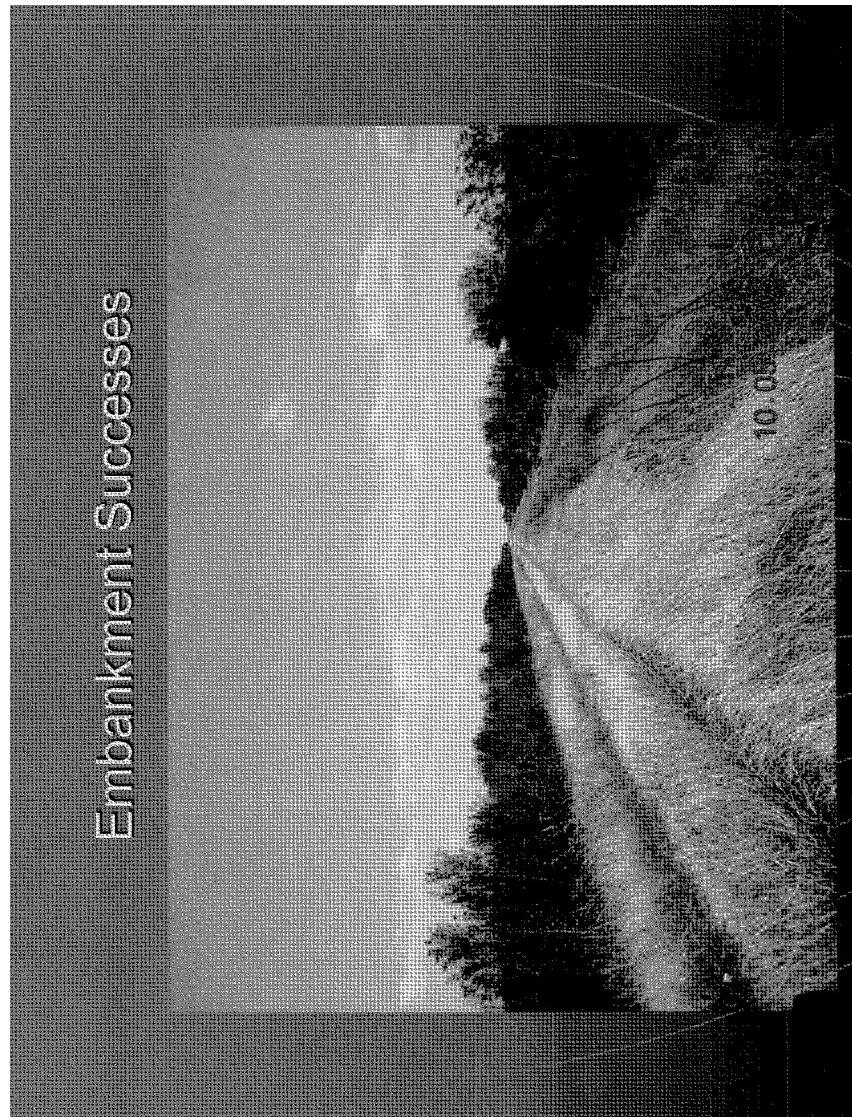
Embankment Successes

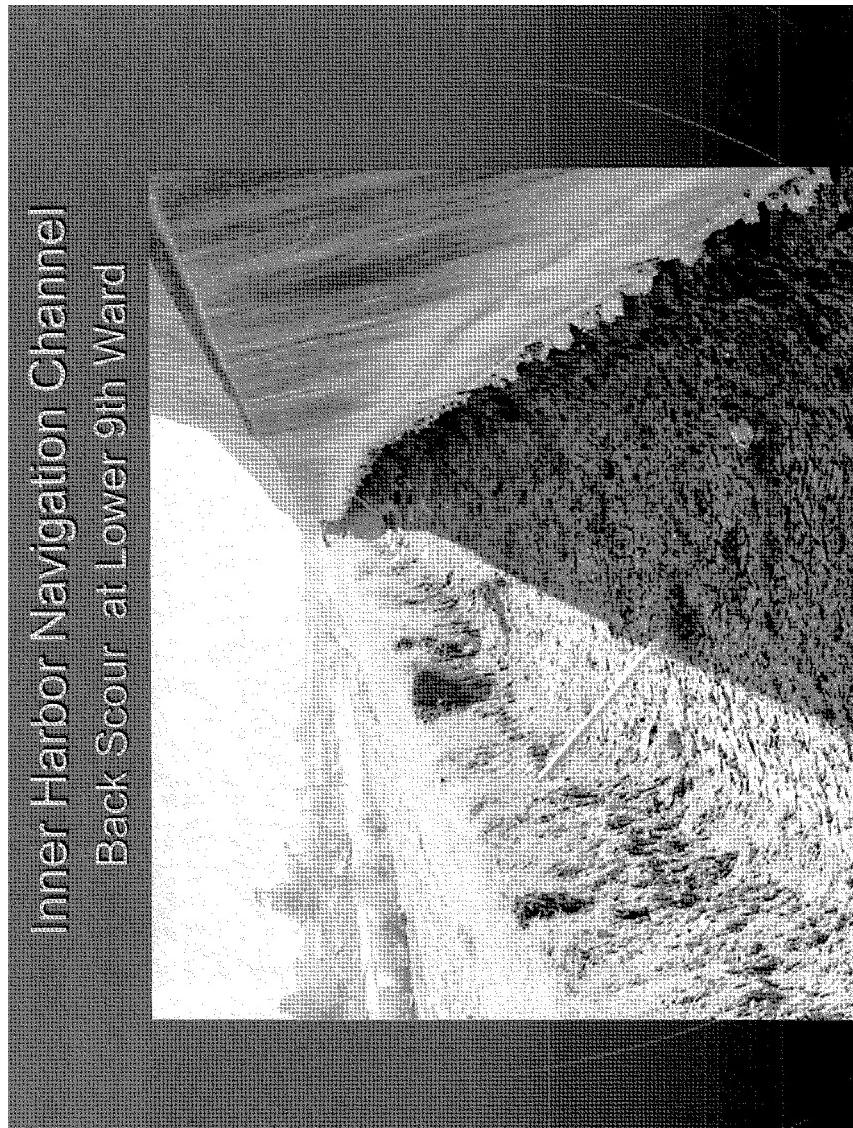
Inner Harbor Navigation Channel
Back Scour at Lower 9th Ward

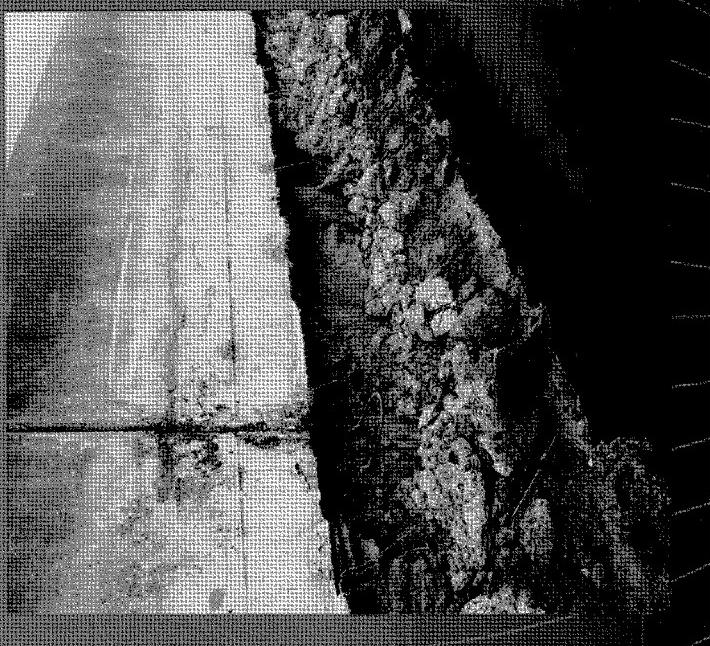
MRGO, North Bank (New Orleans East):
Overtopping Back Scour

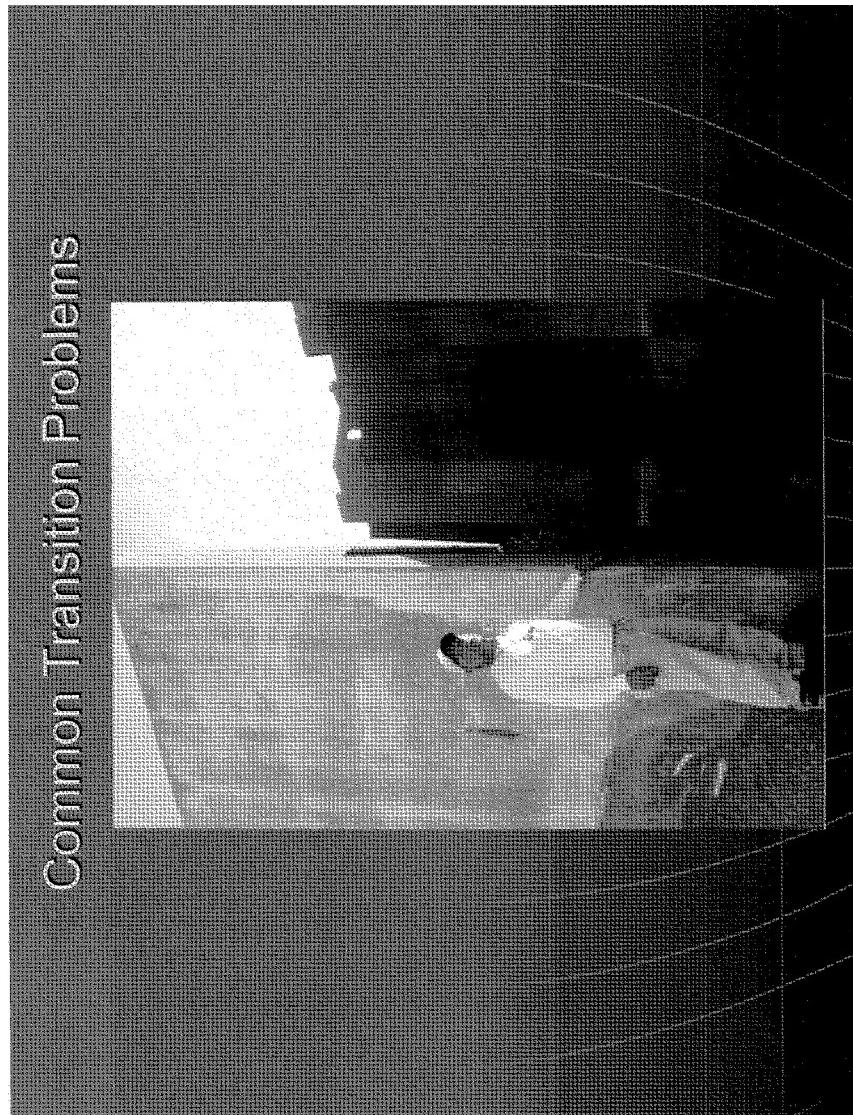
MRGO, North Bank (New Orleans East):
Floodwall Overtopping Failure

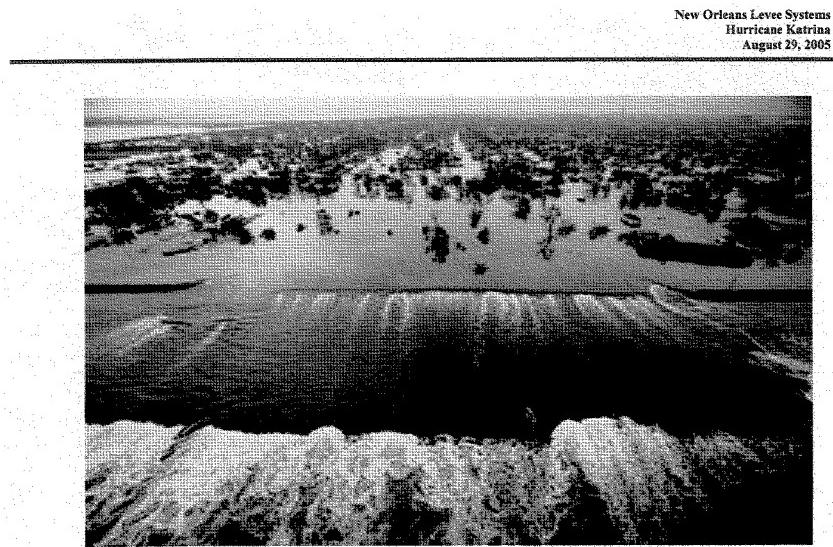
The consequences of the flooding of major portions of all four levee-protected polders were catastrophic. Figure 1.7 shows inundation of the Ninth Ward adjacent to one of the major breaches in the levee along the IHNC. Numerous areas of greater New Orleans were similarly flooded, as shown in Figures 1.4 and 1.5. Large developed areas within all of the main polders were flooded, and they remained inundated for several weeks before levee breaches could be repaired and the waters pumped out.

Figure 1.7: Flooding at the west end of the Ninth Ward, and outflow through levee breach as initial storm surge subsides.

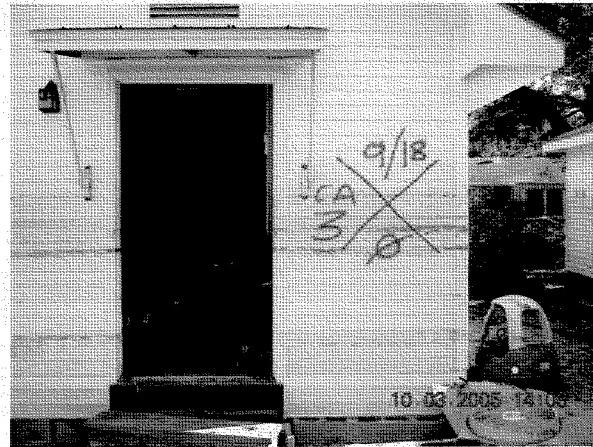
Neighborhoods that were inundated exhibit stark evidence of this catastrophic flooding. Water marks, resembling oversized bathtub rings, line the sides of buildings and cars in these stricken neighborhoods, as shown in Figure 1.8. Household and commercial chemicals and solvents, as well as gasoline, mixed with the salty floodwaters in many

Figure 1.8: High water marks remain on structures after temporary levee repairs have been completed and flood waters have been pumped out.

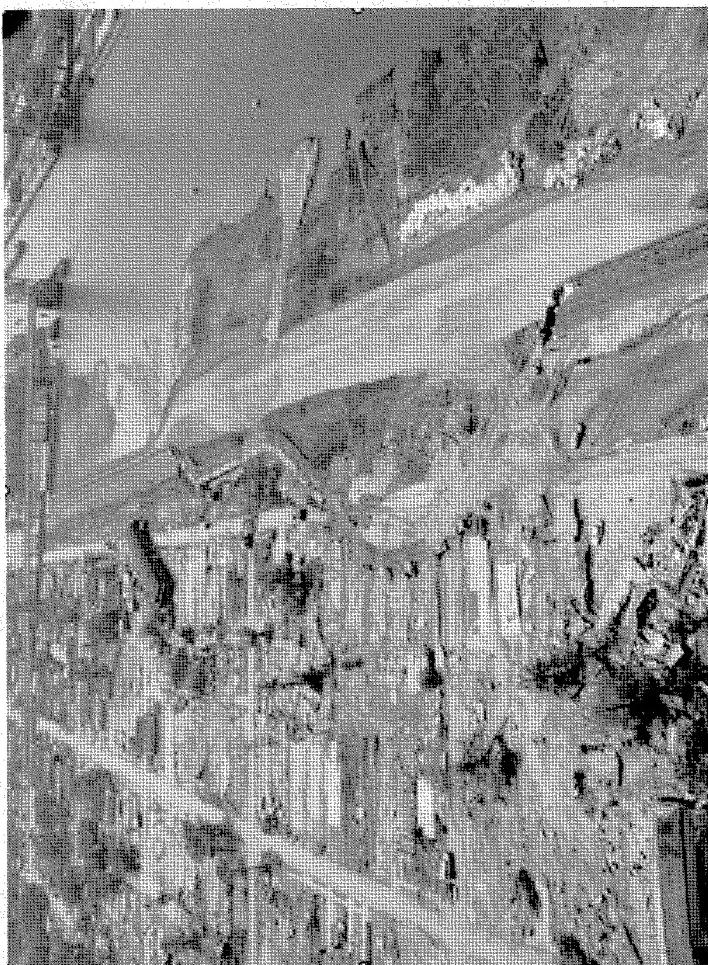
Figure 1.9: Oblique view of the (south) levee break at the Inner Harbor Navigation Canal into the lower Ninth Ward.

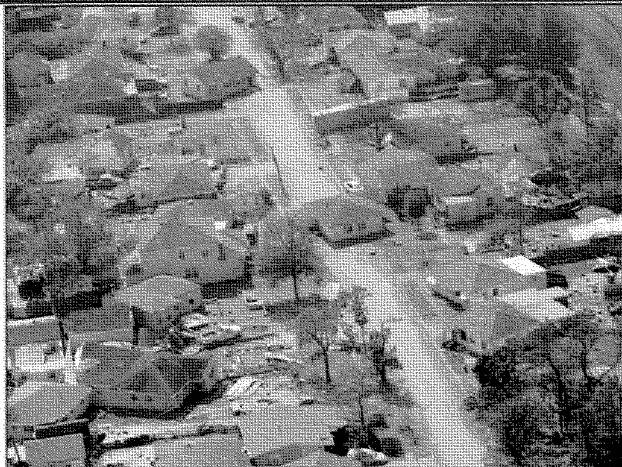
Figure 1.10 shows another aspect of the flooding. This photograph shows a region within St. Bernard Parish in which numerous homes were floated and transported from their original locations by the floodwaters, and then deposited in new locations. Figure 1.11 shows a number of homes in the Plaquemines Parish polder that were carried across the narrow polder (from left to right in this photograph) as the west side (left side of photo) "hurricane levee" or back levee was breached, and were then nearly floated over the crest of the Mississippi River levee. The water side slope face of the Mississippi River levee is clearly shown in this photograph, as evinced by the concrete slope face protection on the outboard side of the riverfront levee in the right foreground of the figure.

Figure 1.10: Flooded neighborhood in St. Bernard Parish, showing homes floated off their foundations and transported by floodwaters.

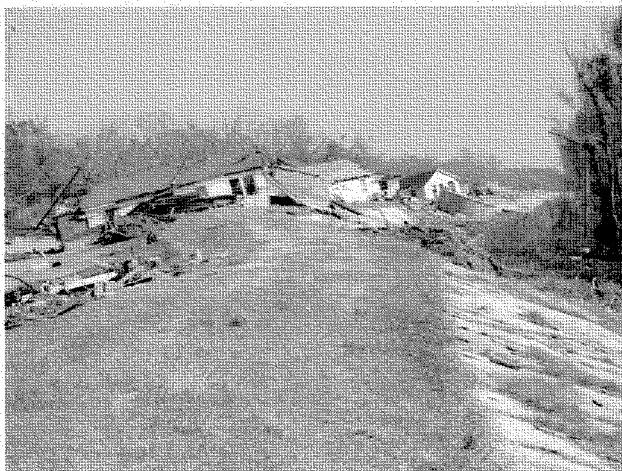
Figure 1.11: Homes in Plaquemines Parish carried from left to right in photo and strewn across the crown of the Mississippi Riverfront levee.

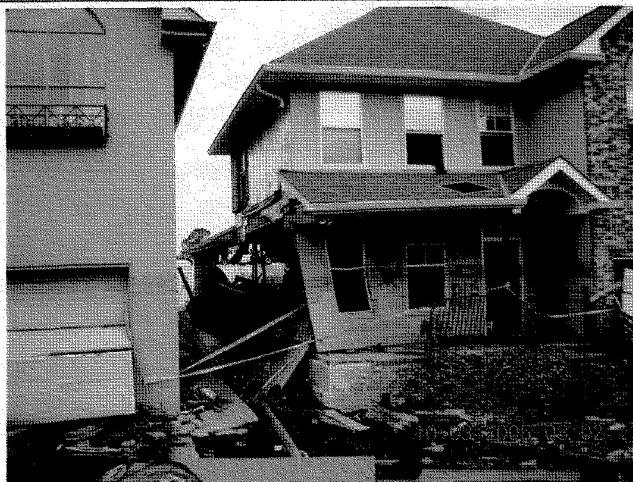
Figure 1.12: Damage to a residential neighborhood in the 17th Street Canal area due to flooding.

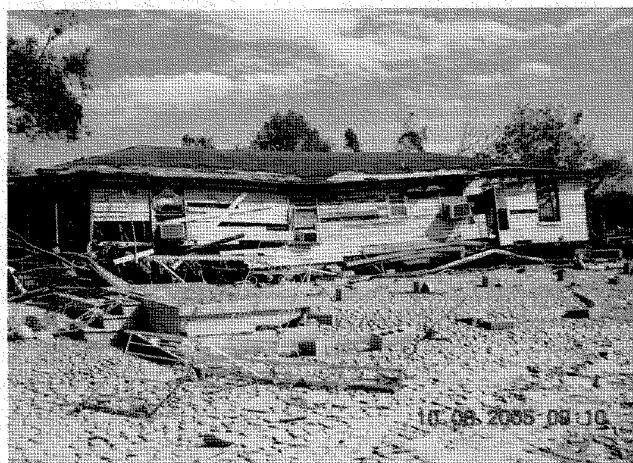
Figure 1.13: Another view of flooding damage, this time in the lower Ninth Ward.

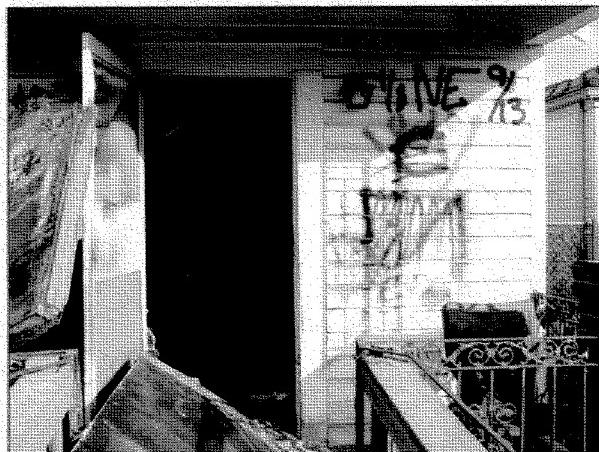
Figure 1.14: Search and rescue team markings on a building in the Ninth Ward where three inhabitants died.

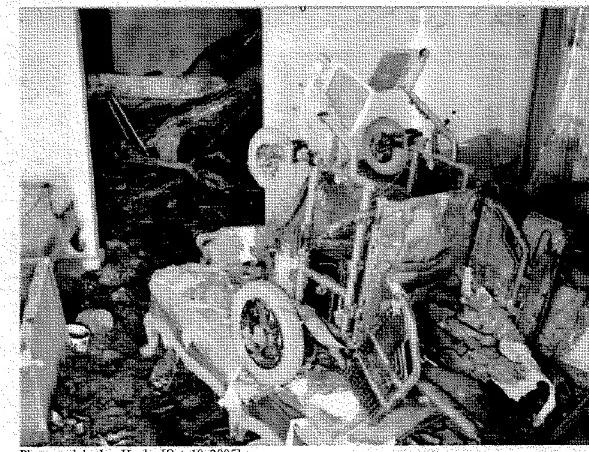
Figure 1.15: View inside structure shown previously in Figure 1.14.

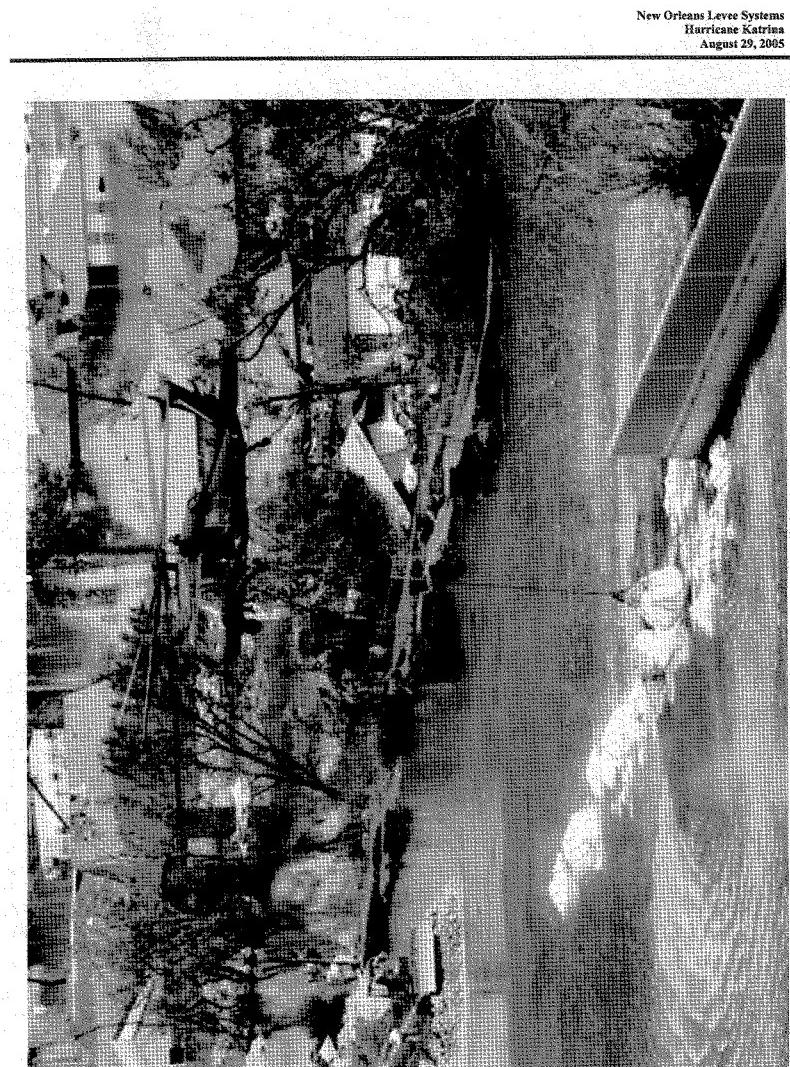
Figure 2.3(a): The 17th Street Canal breach during initial breach closure.

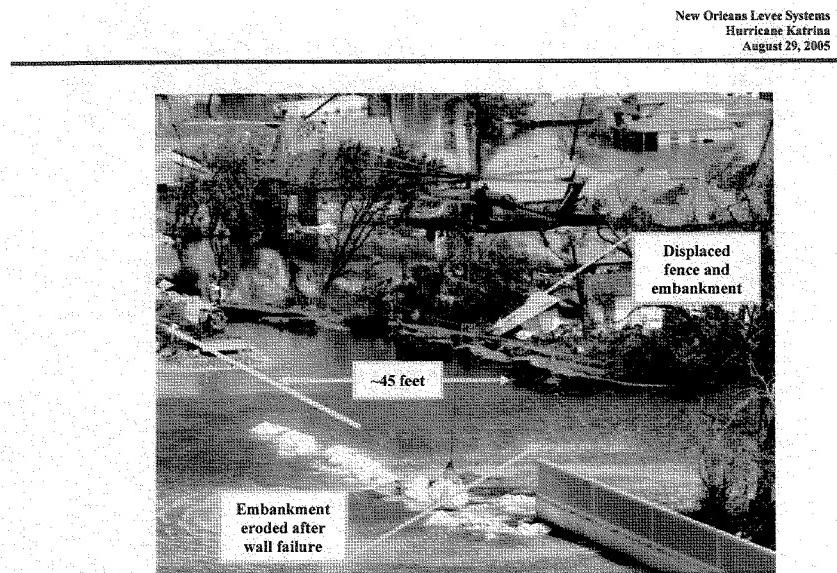
Figure 2.3(b): The 17th Street breach, highlighting key points for discussion

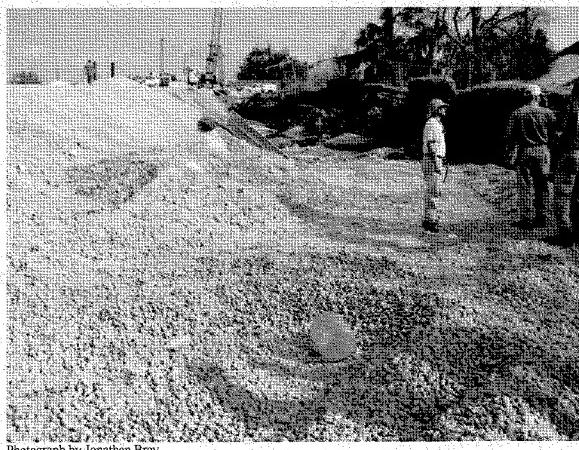
Figure 2.4: View of the 17th Street breach section from the south.

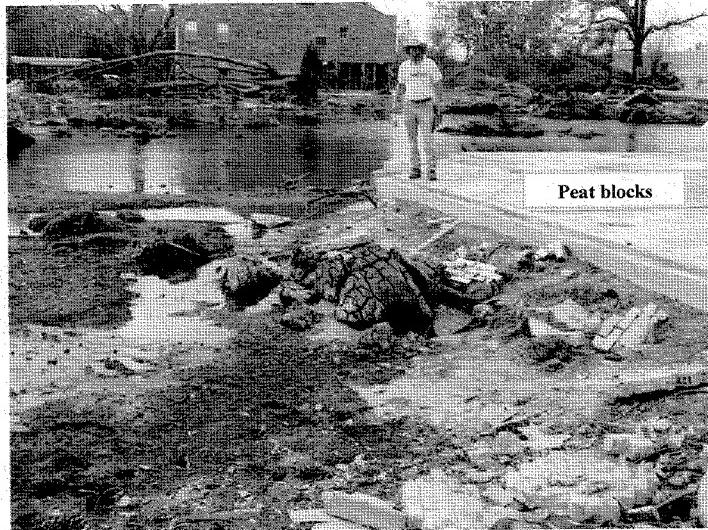
Figure 2.5 shows a view looking east across the zone through which the principal floodwaters flowed. Clearly evident in this photo are large blocks of peat scoured from the eroding foundation by the floodwaters.

Figure 2.5: View from crest of emergency embankment closure section at the 17th Street Canal breach, looking south across the floodwater scoured zone.

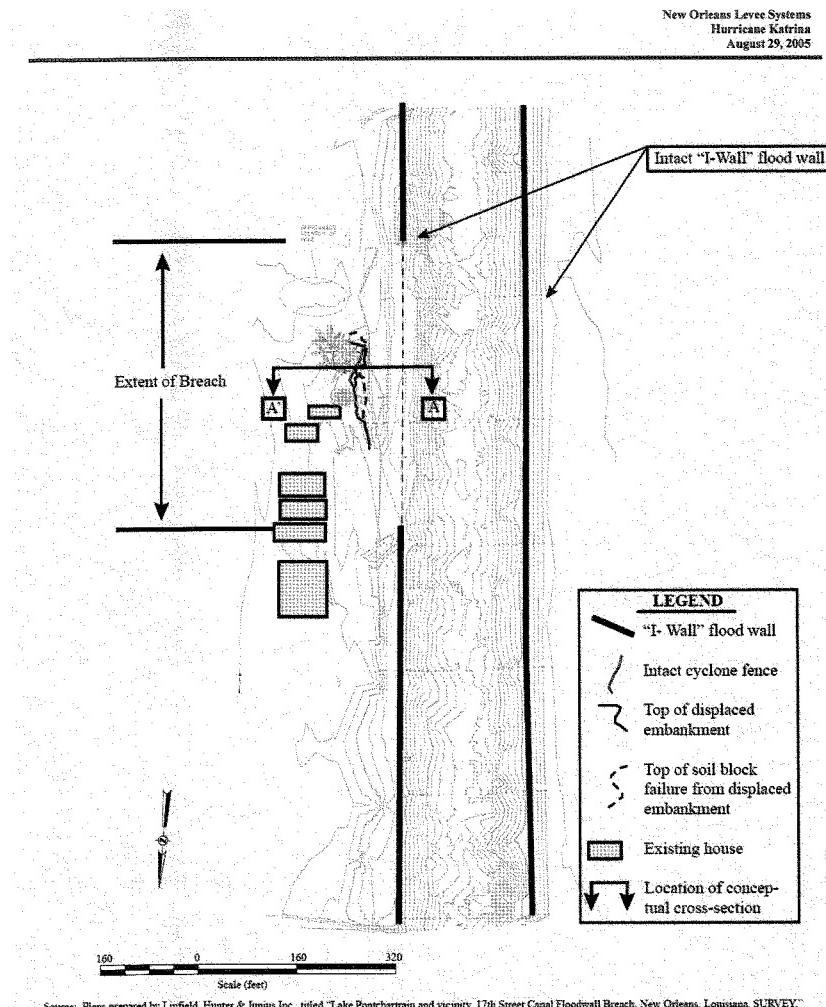
Figure 2.6: Schematic plan view of the 17th Street Canal breach site. Results of LIDAR scan superimposed on base survey.

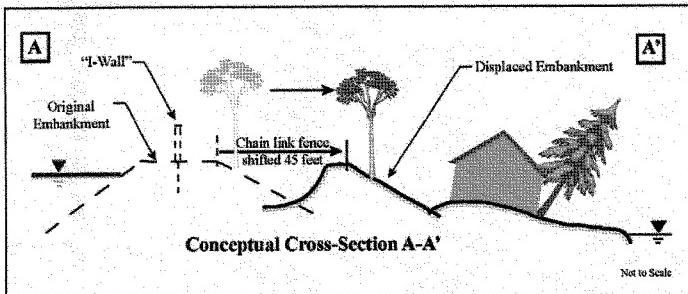
Figure 2.7: Schematic cross section at the 17th Street breach section.

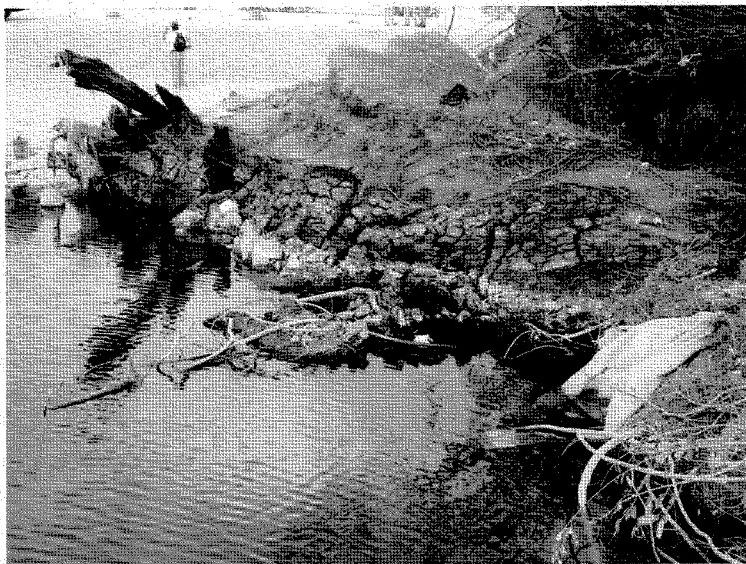
Figure 2.8: Location at which clay seam interbedded within the peat at the toe of the translated levee embankment was sampled.

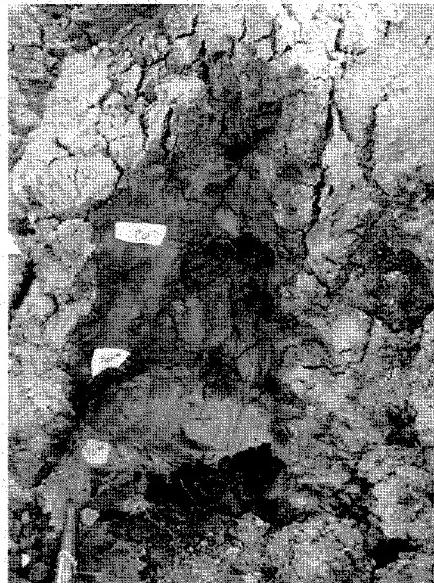
Figure 2.9: Clay seam (light gray layer) underlain by darker lean clay, and overlain by fibrous peat.
